Manhole Inspection Summary

Manhole # S45MM_043MH

Insp Date: **3/25/08 2:44 PM**

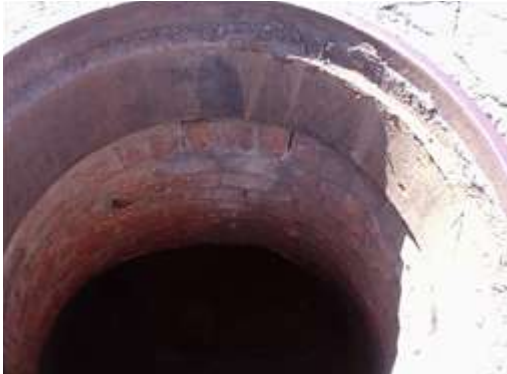
Defect 1

Infiltration: ☐ None ☐ Joint ☐ Cracks ☒ **Mortar** ☐ Roots ☒ **Wall**

Adjustment Joint

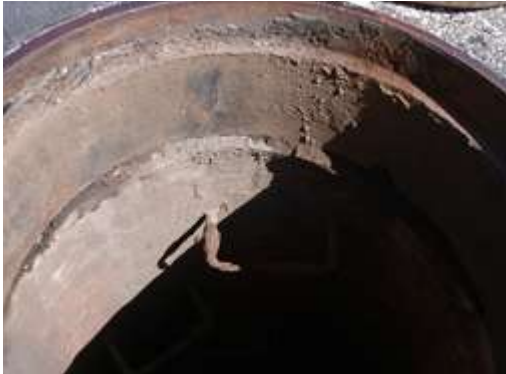
Defect 2

☒ **Leaks**

Frame Leaks

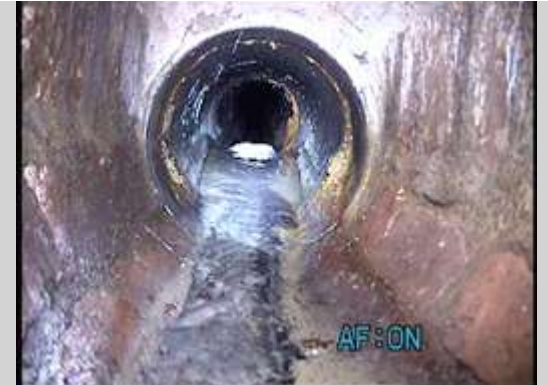
12 O'Clock Outflow

8 in. Circular Gravity Sewer
Pipe Out @ 12 O'Clock

Pipe Height: **8.4** (in.) Rod and Bar (Angled)
Pipe Material: **Clay** ☐ Pipe Lined
Invert Depth: **8.40** (ft.) Flow Characteristics: **Fast**
Deposits: ☒ None ☐ Mud ☐ Sludge ☐ Debris ☐ Grease
Silt Depth: (in.) Deposits Extent:
Infiltration: **None** Pipe Seal Cond: **Sound**

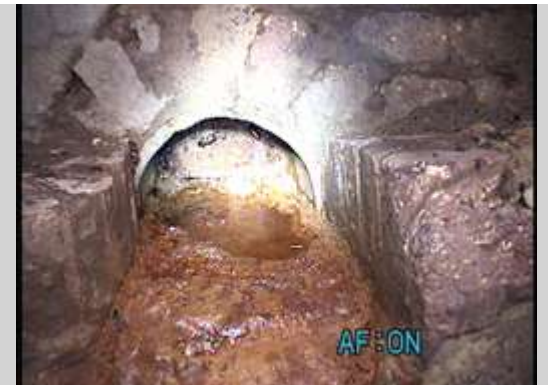
3 O'Clock Inflow

8 in. Circular Gravity Sewer
Pipe In @ 3 O'Clock

Pipe Height: **8.4** (in.) Rod and Bar (Angled)
Pipe Material: **Clay** ☐ Pipe Lined
Invert Depth: **8.20** (ft.) Flow Characteristics: **None**
Deposits: ☐ None ☒ Mud ☒ Sludge ☐ Debris ☐ Grease
Silt Depth: **5** (in.) Deposits Extent: **Heavy**
Infiltration: **None** Pipe Seal Cond: **Sound**

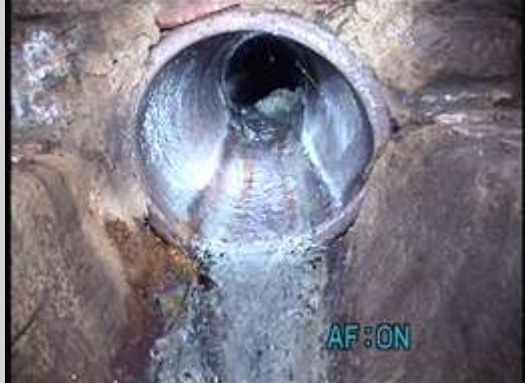
6 O'Clock Inflow

8 in. Circular Gravity Sewer

Pipe In @ 6 O'Clock

Deposits: ☒ None ☐ Mud ☐ Sludge ☐ Debris ☐ Grease
